## The Therac 25

A case study in safety failure

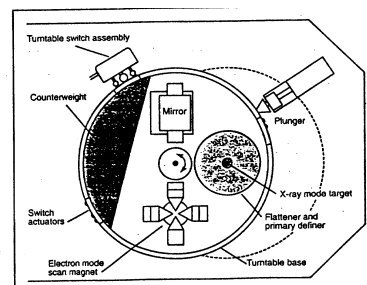
Figure B. Upper turntable assembly.

- Computer adjusts turntable position
- Microswitches detect turntable setting
- 3-bit binary code used to encode turntable setting
- Software checks replace hardware interlocks

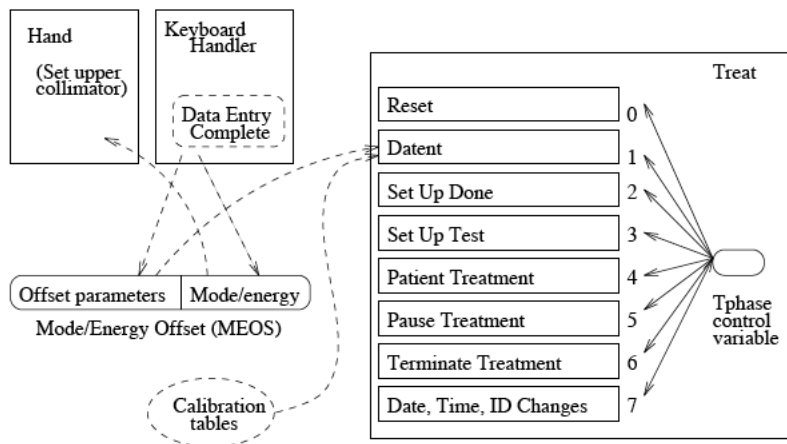
Figure 3: Tasks and subroutines in the code blamed for the Tyler accidents.

The keyboard handler parses the mode and energy level specified by the operator and places an encoded result in another shared variable, the 2-byte Mode/Energy Offset variable (MEOS). The low-order byte of this variable is used by another task (Hand) to set the collimator/turntable to the proper position for the selected mode and energy. The high-order byte of the MEOS variable is used by Datent to set several operating parameters.

Initially, the data-entry process forces the operator to enter the mode and energy except when the photon mode is selected, in which case the energy defaults to 25 MeV. The operator can later edit the mode and energy separately. If the keyboard handler sets the Data Entry Complete flag before the operator changes the data in MEOS, Datent will not detect the changes because it has already exited and will not be reentered again. The upper collimator (turntable), on the other hand, is set to the position dictated by the low-order byte of MEOS by another concurrently running task (Hand) and can therefore be inconsistent with the parameters set in accordance with the information in the high-order byte. The software appears to contain no checks to detect such an incompatibility.

Recall that the Tyler error occurred when the operator made an entry indicating the mode and energy, went to the command line, then moved the cursor up to change the mode or energy and returned to the command line all within eight seconds. Because the magnet setting takes about eight seconds and Magnet does not recognize edits after the first execution of Ptime, the editing had been completed by the return to Datent, which never detected that it had occurred. Part of the problem was fixed after the accident by clearing the bending magnet variable at the end of Magnet (after *all* the magnets have been set) instead of at the end of Ptime.

But this is not the only problem. Upon exit from the Magnet subroutine, the data entry subroutine (Datent) checks the Data Entry Complete variable. If it indicates that data entry is complete, Datent sets Tphase to 3 and Datent is not entered again. If it is not set, Datent leaves Tphase unchanged, which means it will eventually be rescheduled. But the Data Entry Complete variable only indicates that the cursor has been down to the command line, not that it is still there. A potential race condition is set up. To fix this, AECL introduced another shared variable controlled by the keyboard handler task that indicates the cursor is not positioned on the command line. If this variable is set, then prescription entry is still in progress and the value of Tphase is left unchanged.

- First fix plan – June 13, 1986
  - Fixed software to eliminate specific bug
  - Modified software sample-and hold circuits to detect pulse above a threshold. Shut down if have one pulse exceeding threshold, rather than 3.
  - Malfunctions 1-64 now suspend treatment, not pause it
  - Added circuit to turn off beam independent of software
  - Modify editing software to limit cursor up, etc.
  - Modify manuals
- FDA had numerous internal concerns
- FDA Letter of 7/23 agreed conceptually, but complained about lack of specific information to evaluate plan. Requested detailed description of software development procedures.

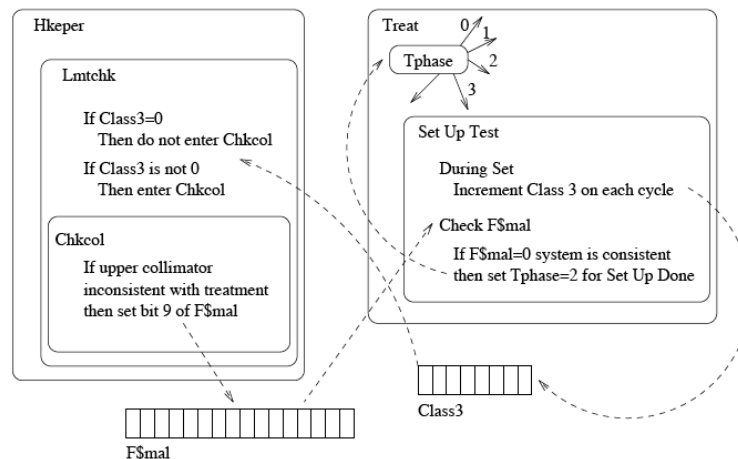
Figure 4: The Yakima software flaw.

During machine setup, Set-Up Test will be executed several hundred times since it reschedules itself waiting for other events to occur. In the code, the Class3 variable is incremented by one in each pass through Set-Up Test. Since the Class3 variable is 1 byte, it can only contain a maximum value of 255 decimal. Thus, on every 256th pass through the Set-Up Test code, the variable overflows and has a zero value. That means that on every 256th pass through Set-Up Test, the upper collimator will not be checked and an upper collimator fault will not be detected.

The overexposure occurred when the operator hit the "set" button at the precise moment that Class3 rolled over to zero. Thus Chkcol was not executed, and F\$mal was not set to indicate the upper collimator was still in field-light position. The software turned on the full 25 MeV without the target in place and without scanning. A highly concentrated electron beam resulted, which was scattered and deflected by the stainless steel mirror that was in the path.

- Numerous hardware and software changes
- All interruptions related to dosimetry not continuable
- independent hardware & software shutdowns
- potentiometer on turntable
- hardware interlocks
- “dead man switch” motion enable
- Fix documentation, messages, & user manuals
- etc
