## The Therac 25

A case study in safety failure

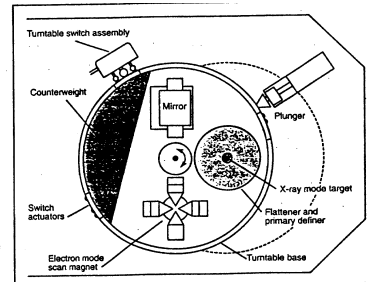
Figure B. Upper turntable assembly.

- Electron mode
  - 5-25 MEV
  - Magnets spread beam
  - Ion chamber monitor
- X-ray mode
  - 25 MEV electrons hit target
  - “Beam flattener” attenuates
  - 100x beam current
  - Ion chamber monitor
- Field-light mode
  - No current
  - Mirror & light used to check alignment
  - No ion chamber (since not treating)
